Manhole Inspection Summary

Manhole # S27C1_005MH

Insp Date: **4/15/08 10:33 AM**

Location Address: **BEHIND 2310 CEDLEY ST.**

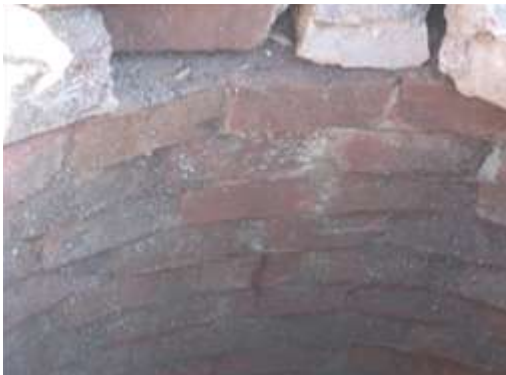
Defect 3

LOOSE BRICKS AND MISSING MORTAR WITH EVIDENCE OF INFILTRATION

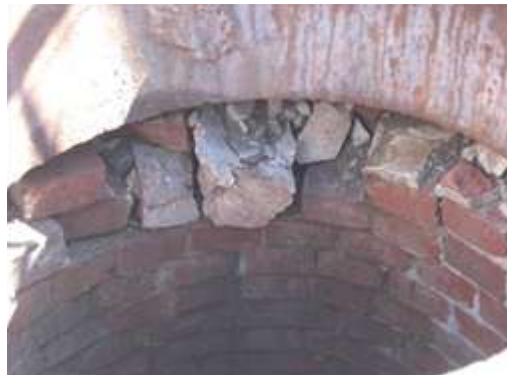
Defect 1

Condition: ☐ Sound ☐ Cracked ☐ Root Intrusion ☒ **Loose Brick** ☐ Deteriorated

Infiltration: ☐ None ☐ Joint ☒ **Cracks** ☒ **Mortar** ☐ Roots ☐ Wall

MISSING MORTAR AND BRICK WITH LOOSE BRICKS AT THE CHIMNEY

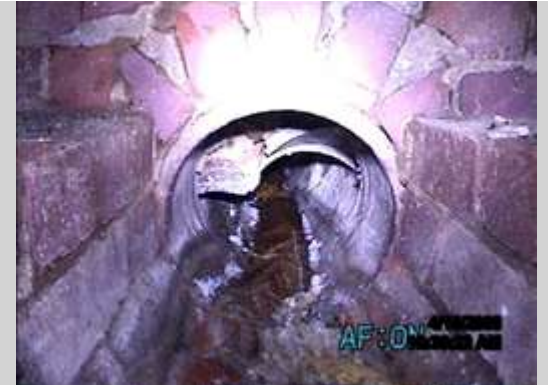
12 O'Clock Outflow

Pipe Height: **8.4** (in.) Rod and Bar (Angled)
Pipe Material: **Clay** ☐ Pipe Lined
Invert Depth: **7.24** (ft.) Flow Characteristics: **Slow**
Deposits: ☐ None ☐ Mud ☐ Sludge ☒ **Debris** ☐ Grease
Silt Depth: **0** (in.) Deposits Extent: **Medium**
Infiltration: **None** Pipe Seal Cond: **Sound**

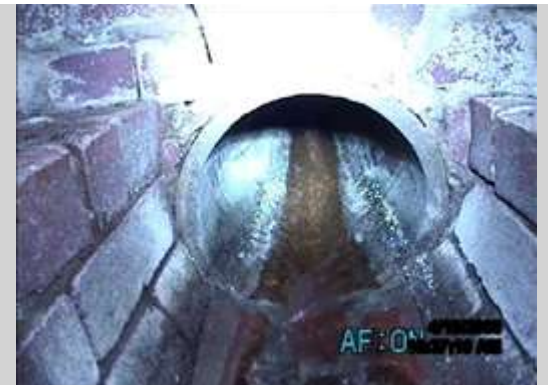
6 O'Clock Inflow

Pipe Height: **8.4** (in.) Rod and Bar (Angled)
Pipe Material: **Clay** ☐ Pipe Lined
Invert Depth: **7.13** (ft.) Flow Characteristics: **Slow**
Deposits: ☒ **None** ☐ Mud ☐ Sludge ☐ Debris ☐ Grease
Silt Depth: **0** (in.) Deposits Extent:
Infiltration: **None** Pipe Seal Cond: **Sound**
